# Evaluation of a cleaning robot on PV modules regarding its influence on electrical and optical module properties

| Report number | V 235/2025 |

# Task description

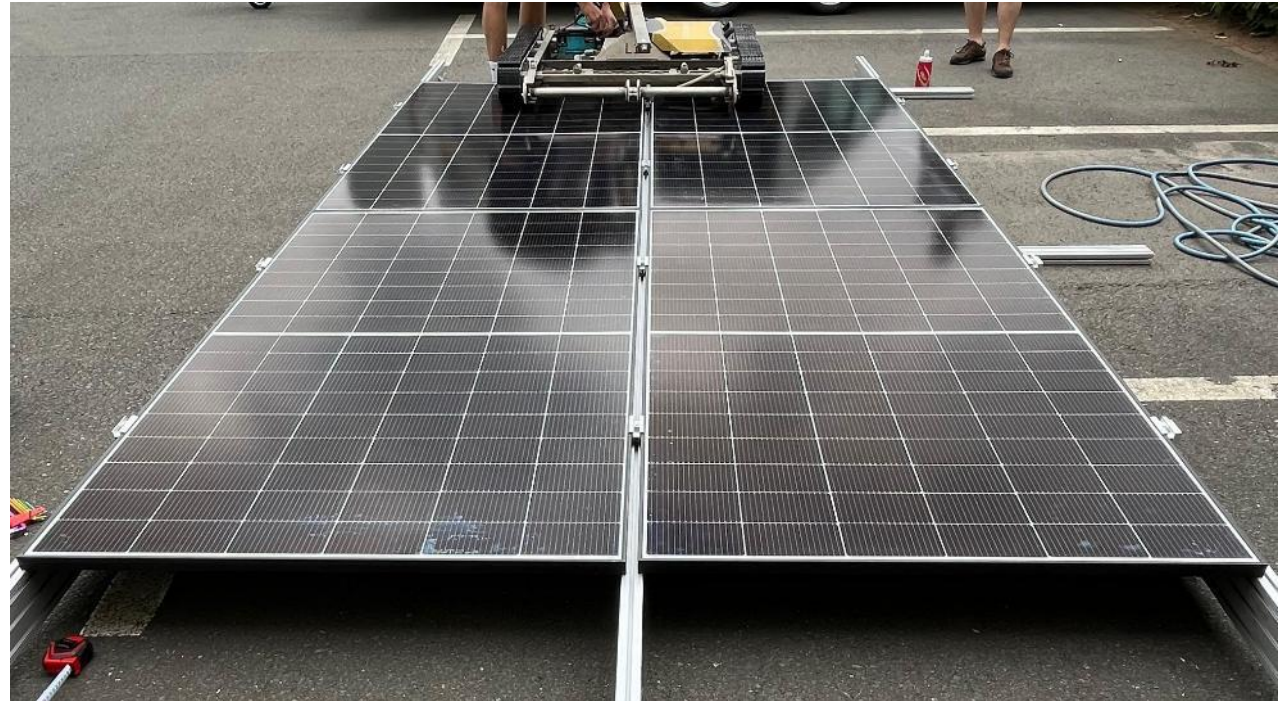
- A corresponding horizontal test setup was installed for flat lying PV modules on a thin mounting structure over the ground to be passed over with the cleaning robot including brushes and activated water system.

- After initial module characterization, the cleaning robot makes 200 cleaning passes over the modules in direction of the module length. The modules are characterized again, and the robot makes another 200 cleaning passes perpendicular to the module length with subsequent final characterization of the modules.

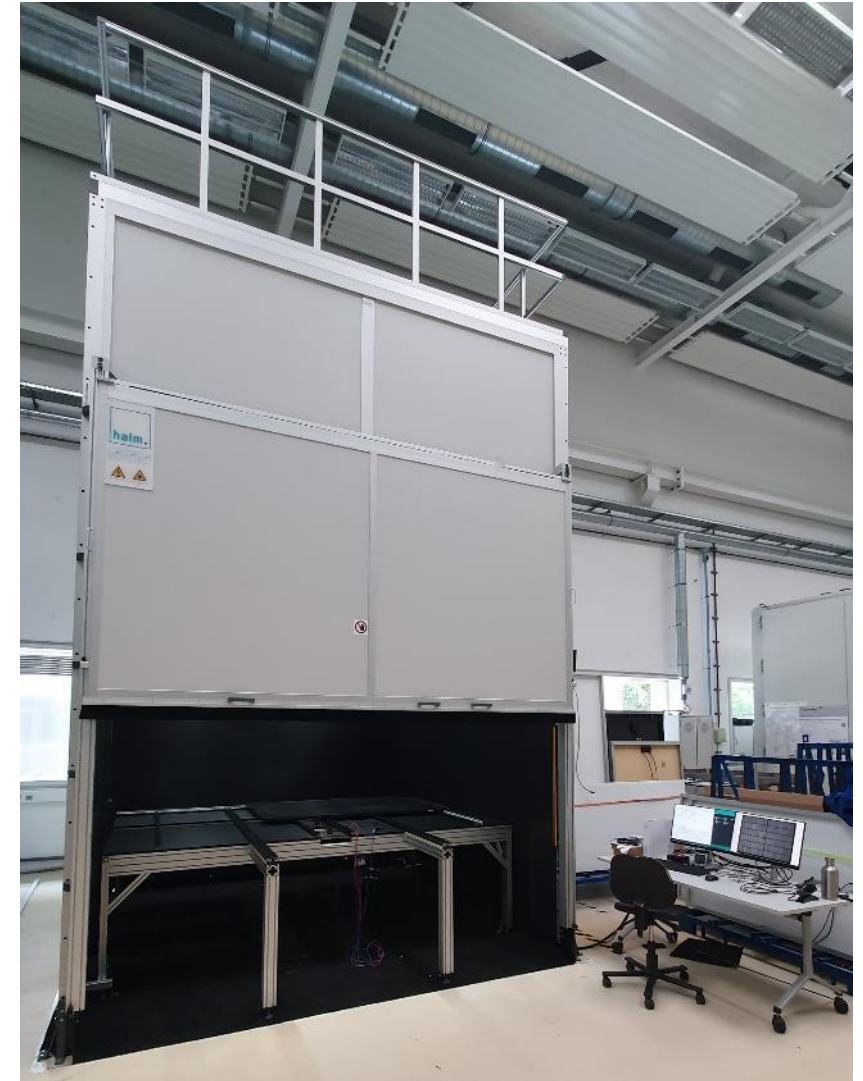
**Equipment: Halm elektronik Solar Simulator cetisPV-Moduletest4**

- STC (standard test conditions):  $(25 \pm 1)^\circ\text{C}$ , irradiation  $1000 \text{ W/m}^2$ , Spectrum AM1.5
- Flash length : 85 ms
- Measurements are made without spectral mismatch correction
- Integrated EL measurement near  $I_{\text{SC}}$

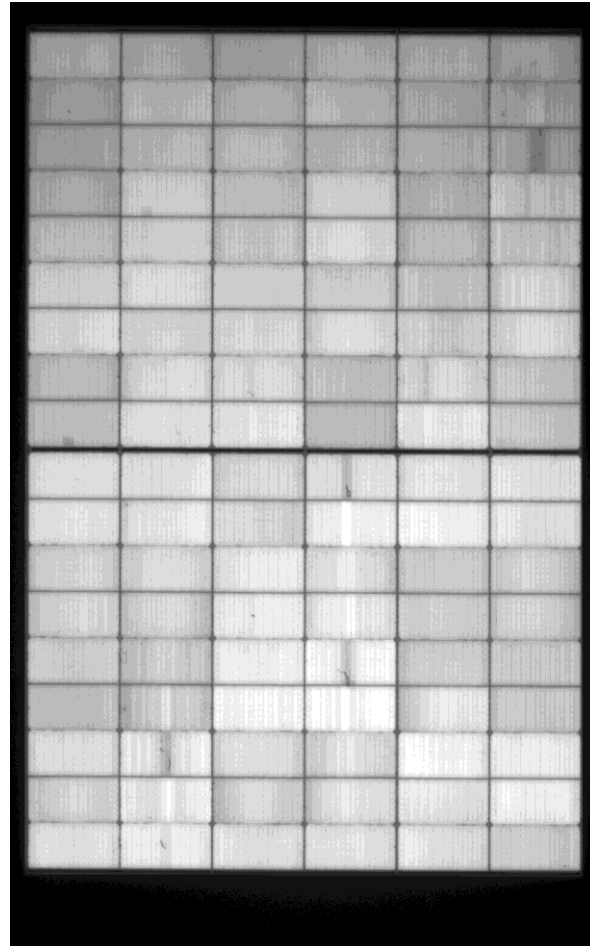
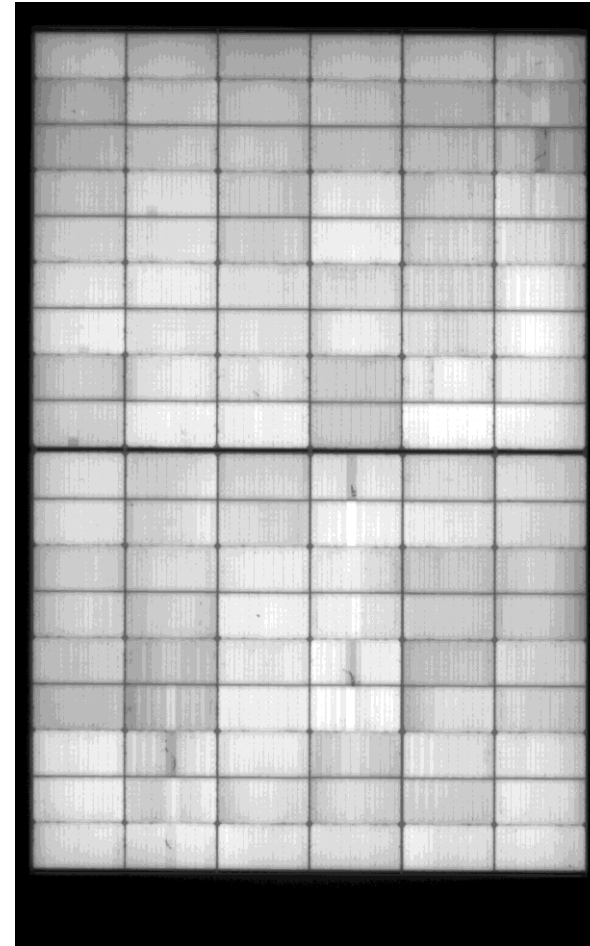
- Manufacturer: Longi
- Type: LR5-54HTH\_440M
- CSP\_SolOur\_2\_P10
  - EL image @  $1/10 I_{SC} = 1.4 \text{ A}$
  - No significant changes detected like:
    - additional cracks
    - crack growth

initial

200 passes in direction  
of module length

200 passes perpendicular  
to module length

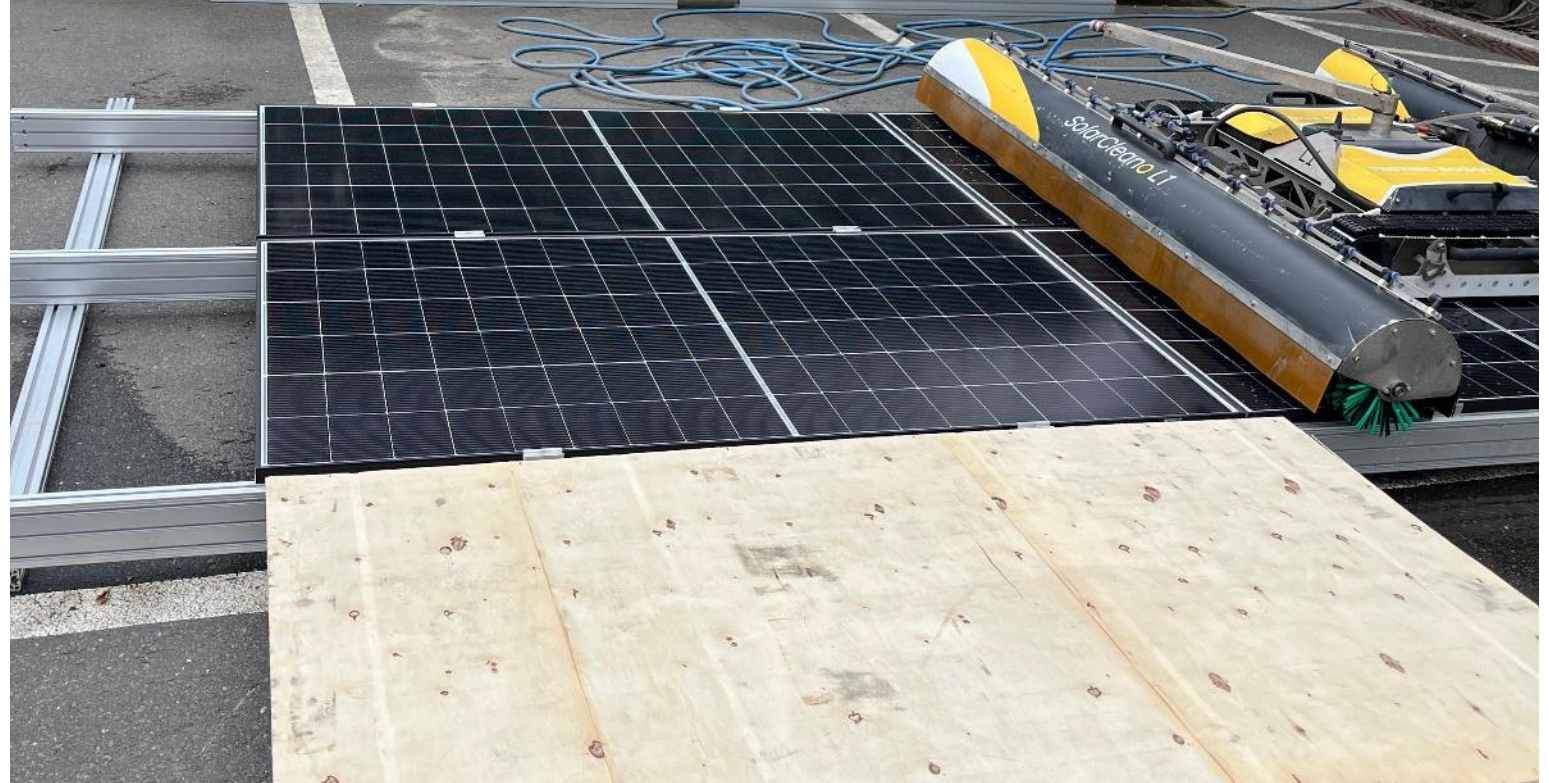
- The influence of the cleaning robot during operation in terms of mechanical and electrical stability of the investigated PV modules is not harmful to the module performance or the electrical-mechanical integrity with the applied test methods.
- The test drives of 400 passes over the modules (200 in direction of the module length and 200 perpendicular to it) show no significant changes in electroluminescence images and power measurement (considering the progressively increased module temperature and the associated increased measurement uncertainty).
