# Evaluation of a cleaning robot on PV modules regarding its influence on electrical and optical module properties

| Client | SolarCleanO |

| Report number | V 262/2024 |

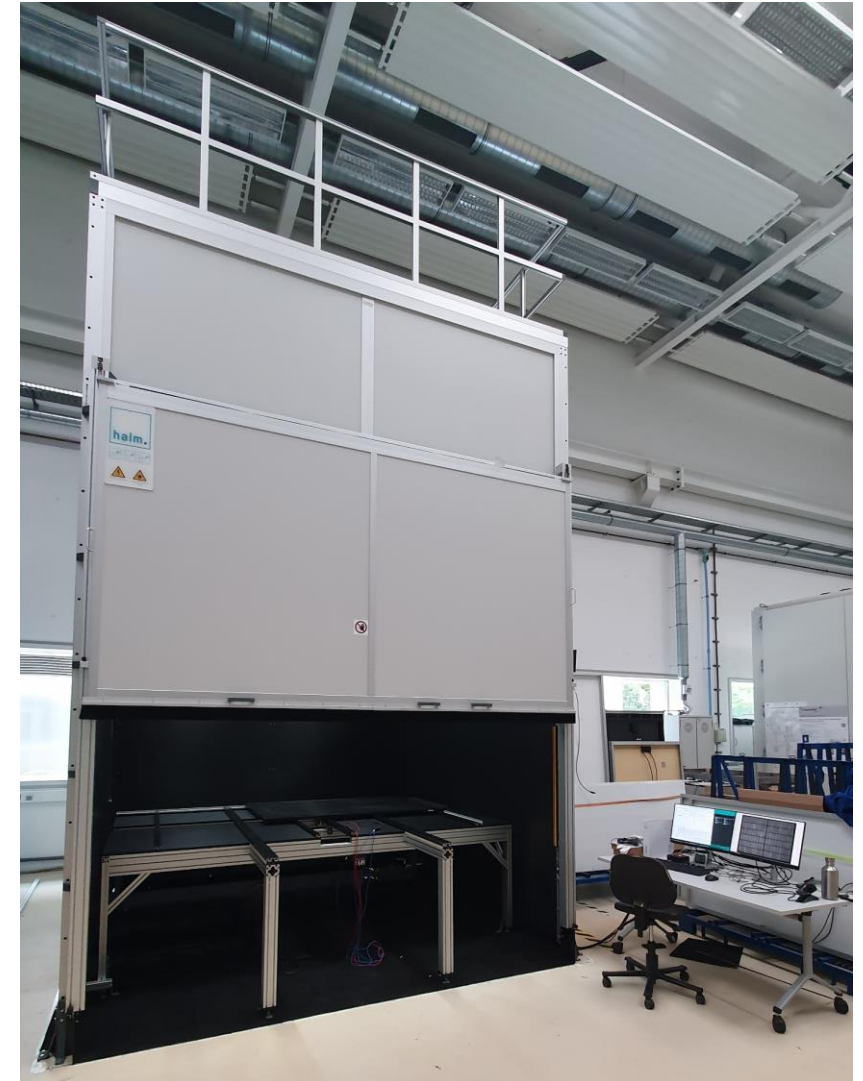
**Equipment: Halm elektronik Solar Simulator cetisPV-Moduletest4**

- STC (standard test conditions):  $(25 \pm 1)^\circ\text{C}$ , irradiation  $1000 \text{ W/m}^2$ , Spectrum AM1.5
- Flash length : 85 ms
- Measurements are made without spectral mismatch correction
- Integrated EL measurement near  $I_{\text{SC}}$
